The Central Chile Mega Drought (2010–2018): A climate dynamics perspective

Pero volviendo a Petorca...

Water Crisis in Petorca Basin, Chile: the Combined Effects of a Mega-Drought and Water Management

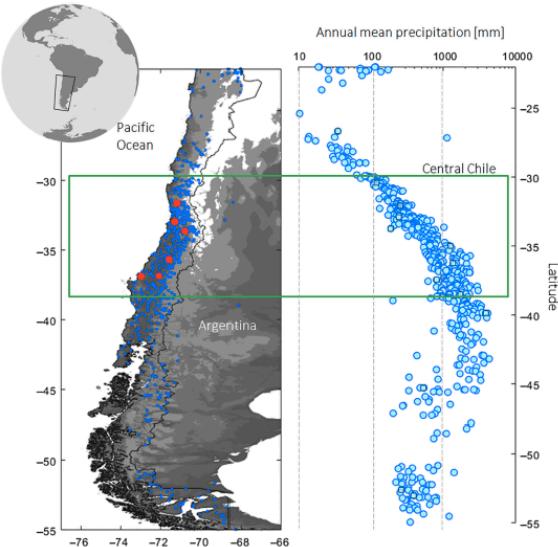
FIGURE 1 Geographic and climate features of Central Chile. (a) Topographic map (dark grey: Terrain elevation <500 m asl; light grey: 500–3,000 m asl; white: > 3,000 m asl). Blue dots are rain gauge stations operated by DMC/DGA. Red circles are the location of the six stations used to define the regional precipitation index. Stations that provide records for Figure 4 are also indicated. (b) Station-based annual mean rainfall (1980–2010) according to latitude [Colour figure can be viewed at wileyonlinelibrary.com]

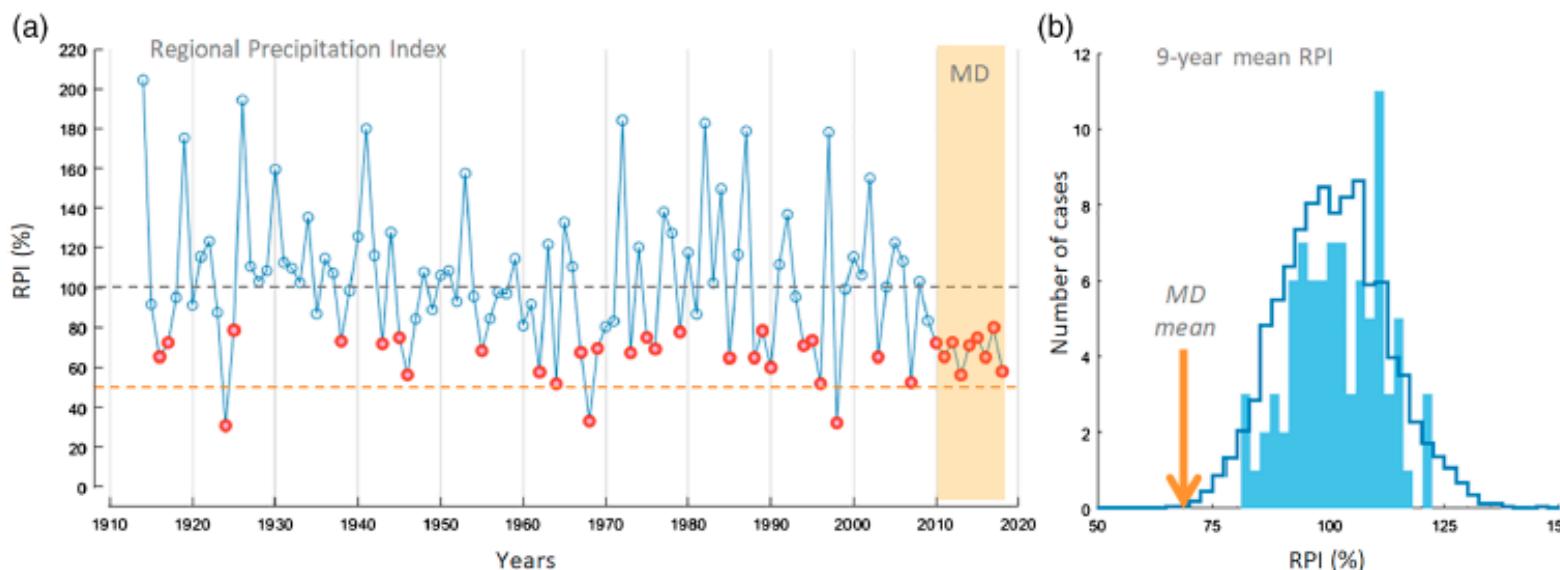
FIGURE 2 (a) Annual series of Central Chile regional precipitation index (RPI). Droughts, defined as years with RPI < 80%, are identified by the red circles. (b) Histogram of 9-year average of RPI for the period 1915–2009. The light blue bars show the observed frequency, considering a 9-year sliding window throughout the 1915–2009 record. The blue thick line is the distribution obtained from 5,000 randomly selected 9 years from the historical period. The orange arrow indicates the RPI averaged during the MD (2010–2018) [Colour figure can be viewed at wileyonlinelibrary.com]

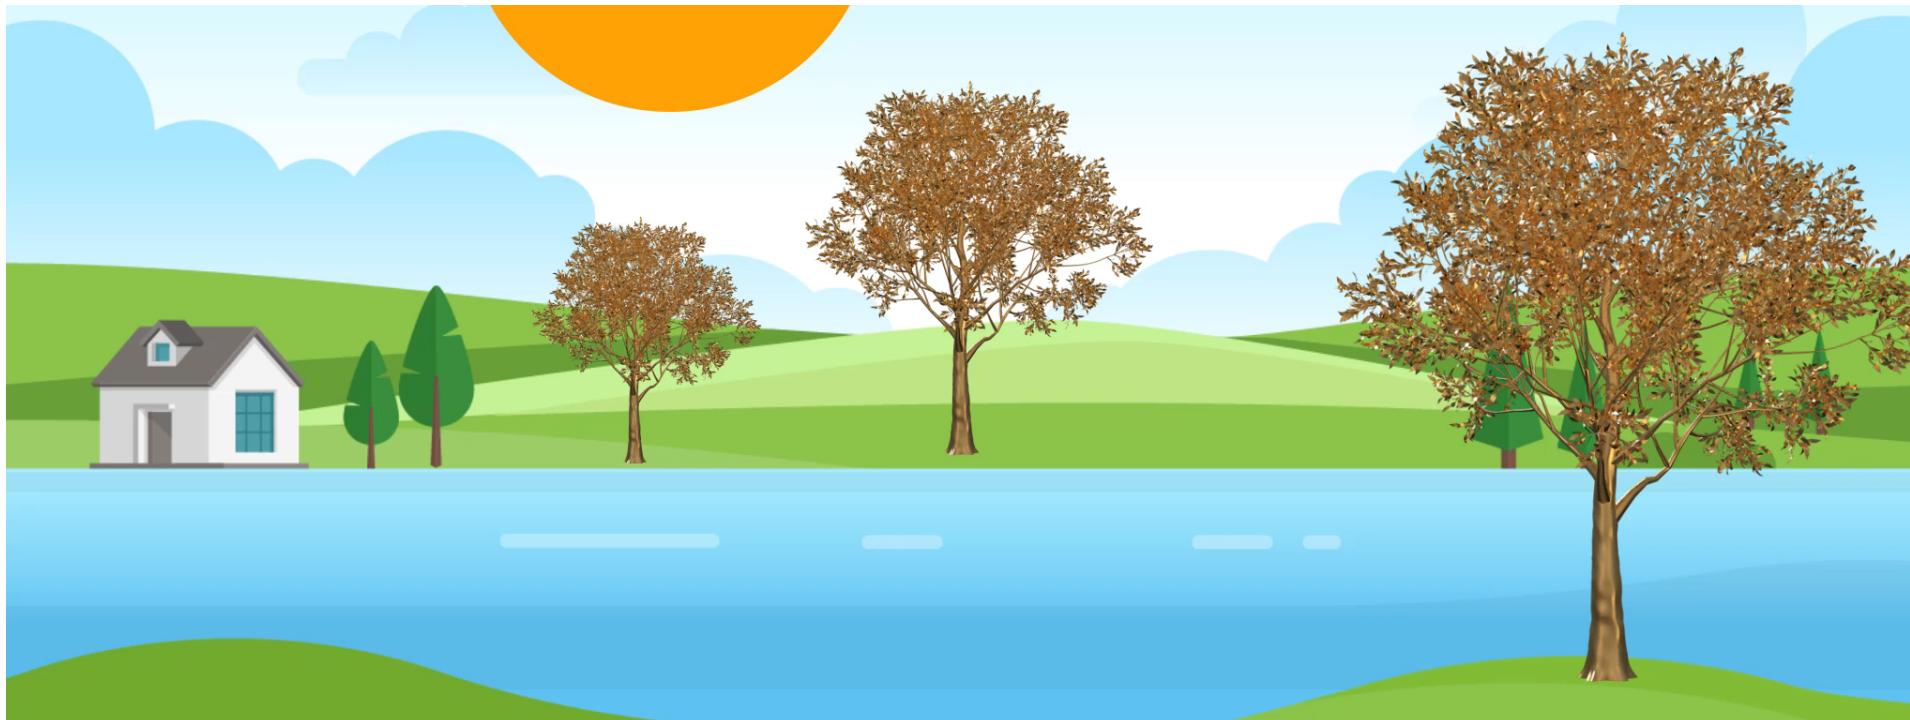
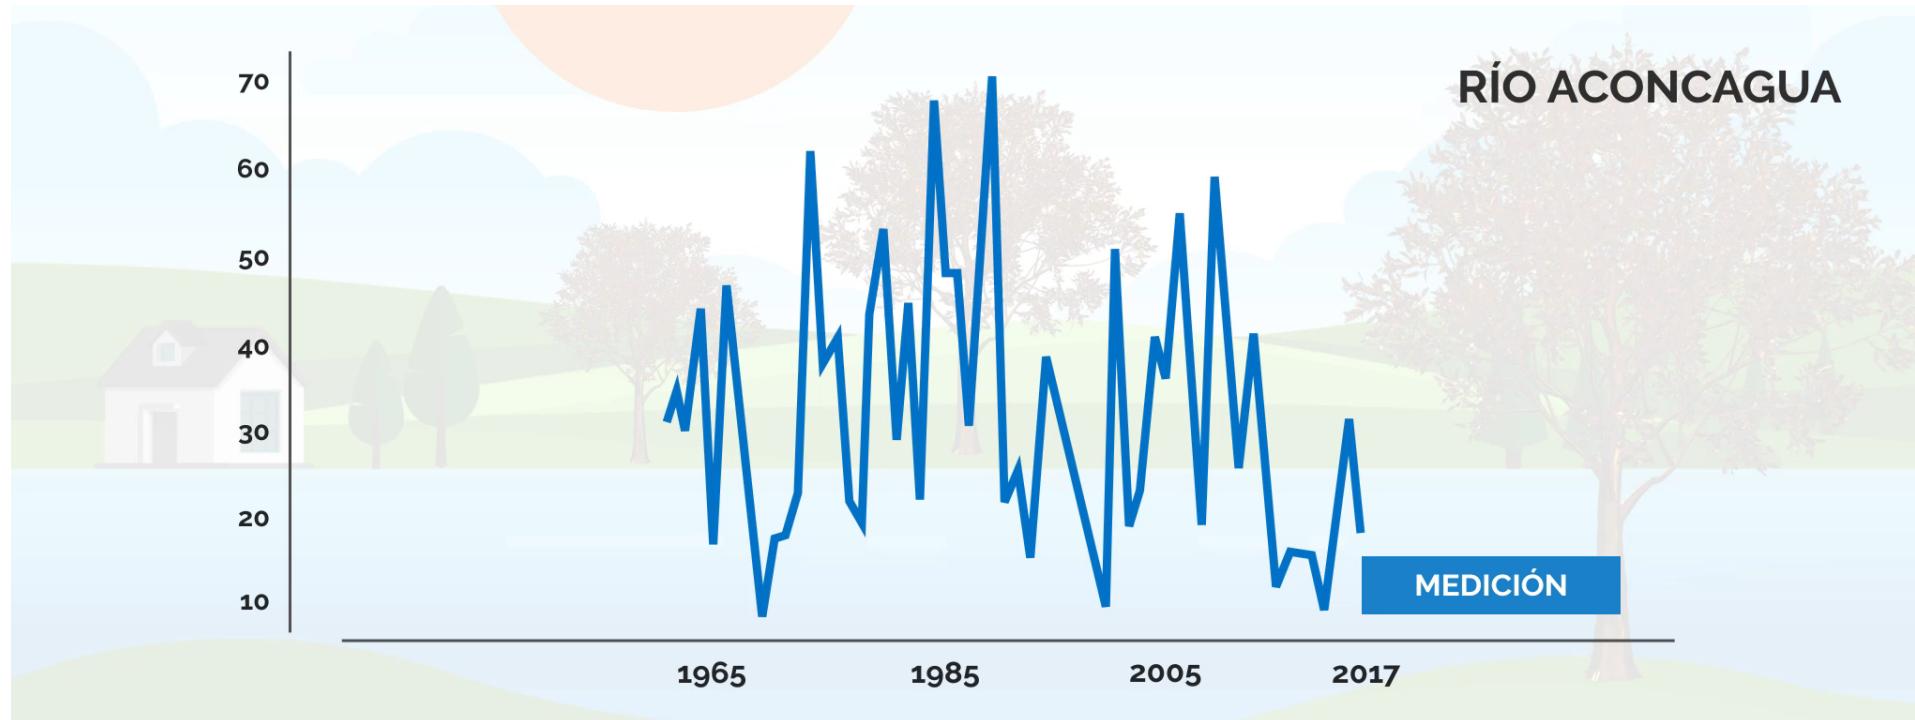
Anillo Ancho
Temporada Húmeda

Anillo Angosto
Temporada Seca

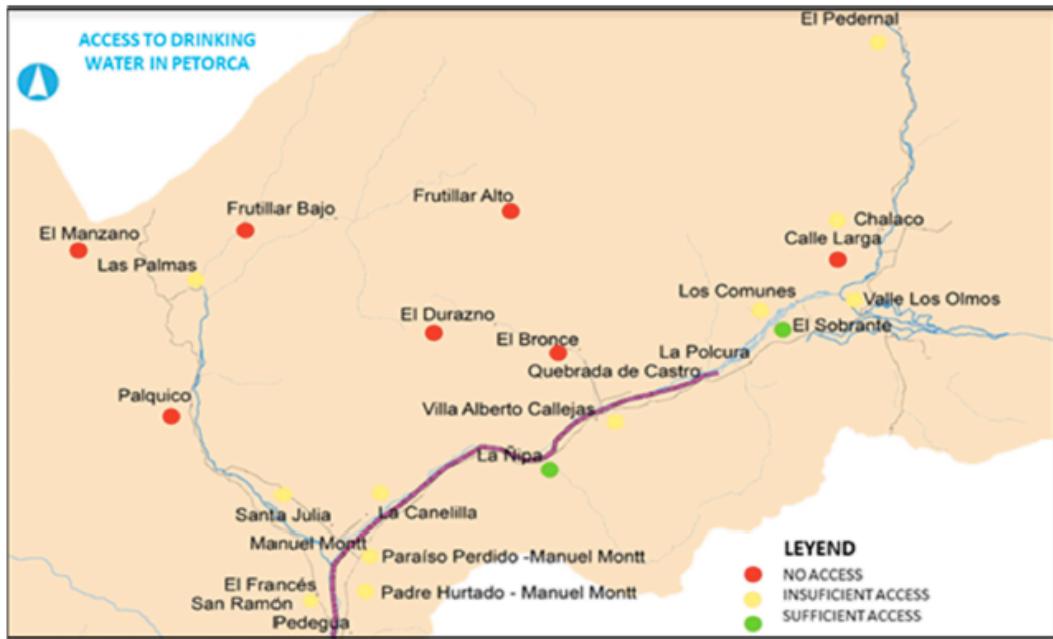
Figure A1. Access to drinking water in Petorca, considering the situation up to December 2019.

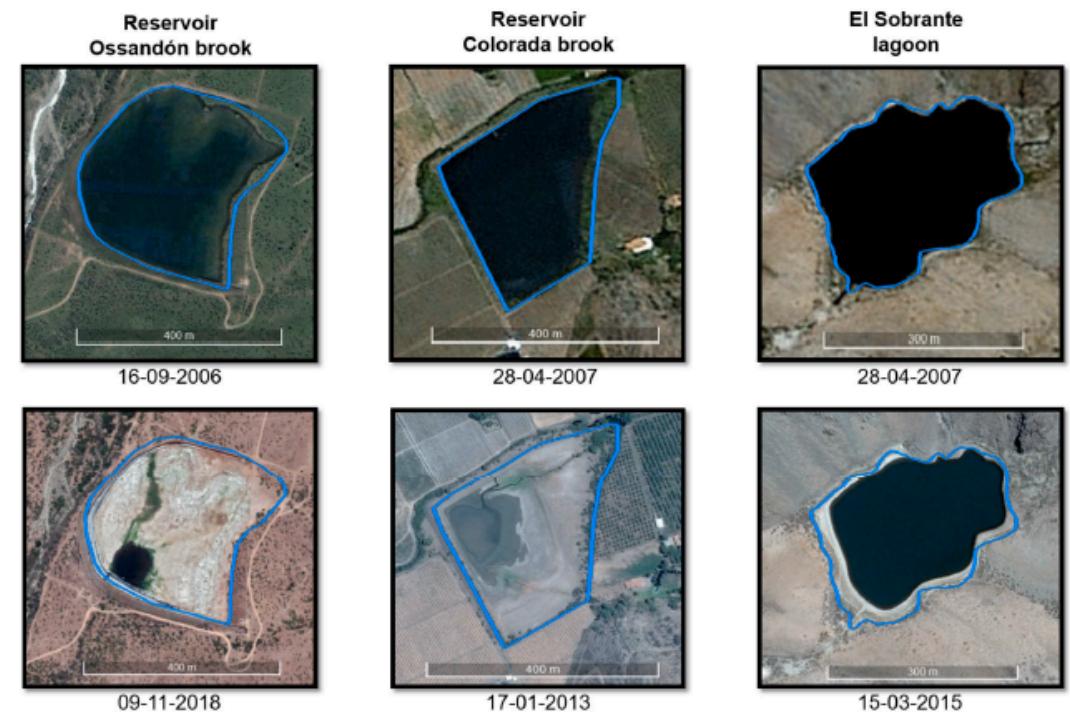
FigureA2. Examples of the dramatic fluctuations in area for the main water bodies of the Petorca basin. Source: Google Earth
